Manhole Inspection Summary

Manhole # S29MM1008MH

Location Address: **226 COLD SPRING LN**

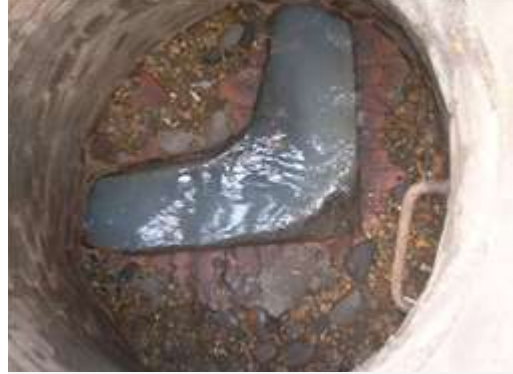
Top View

Corroded steps. Bench debris.

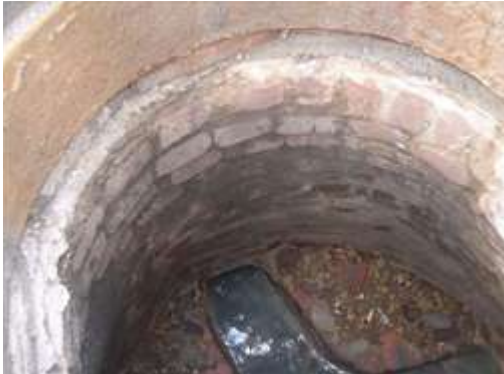
Defect

Frame leaks. Corbel deterioration and infiltration. Barrel infiltration.

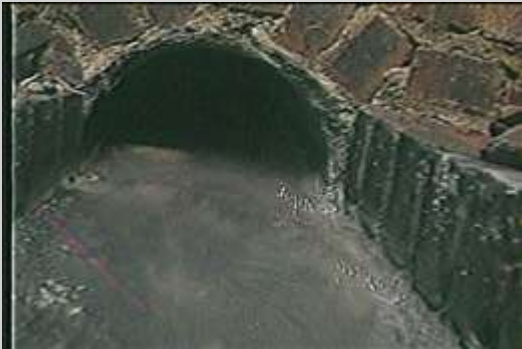
10 in. Circular Gravity Sewer Pipe Out @ 12 O'Clock

Deposits: ☐ None ☒ **Mud** ☐ Sludge ☒ **Debris** ☐ Grease

Silt Depth: **1** (in.) Deposits Extent: **Light**

Infiltration: **Evidence** Pipe Seal Cond: **Cracked**

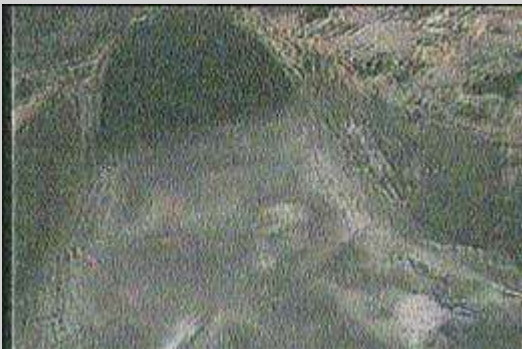
10 in. Circular Gravity Sewer Pipe In @ 9 O'Clock

Deposits: ☐ None ☒ **Mud** ☐ Sludge ☒ **Debris** ☐ Grease

Silt Depth: **1** (in.) Deposits Extent: **Light**

Infiltration: **Evidence** Pipe Seal Cond: **Unknown**
